LANDSLIDES AND RELATED FEATURES

OF THE MONTEAGLE, TENN. QUADRANGLE

by
Roger E. Thomas
1981

U.S. Geological Survey
OPEN FILE MAP 81-1318 (B-2)

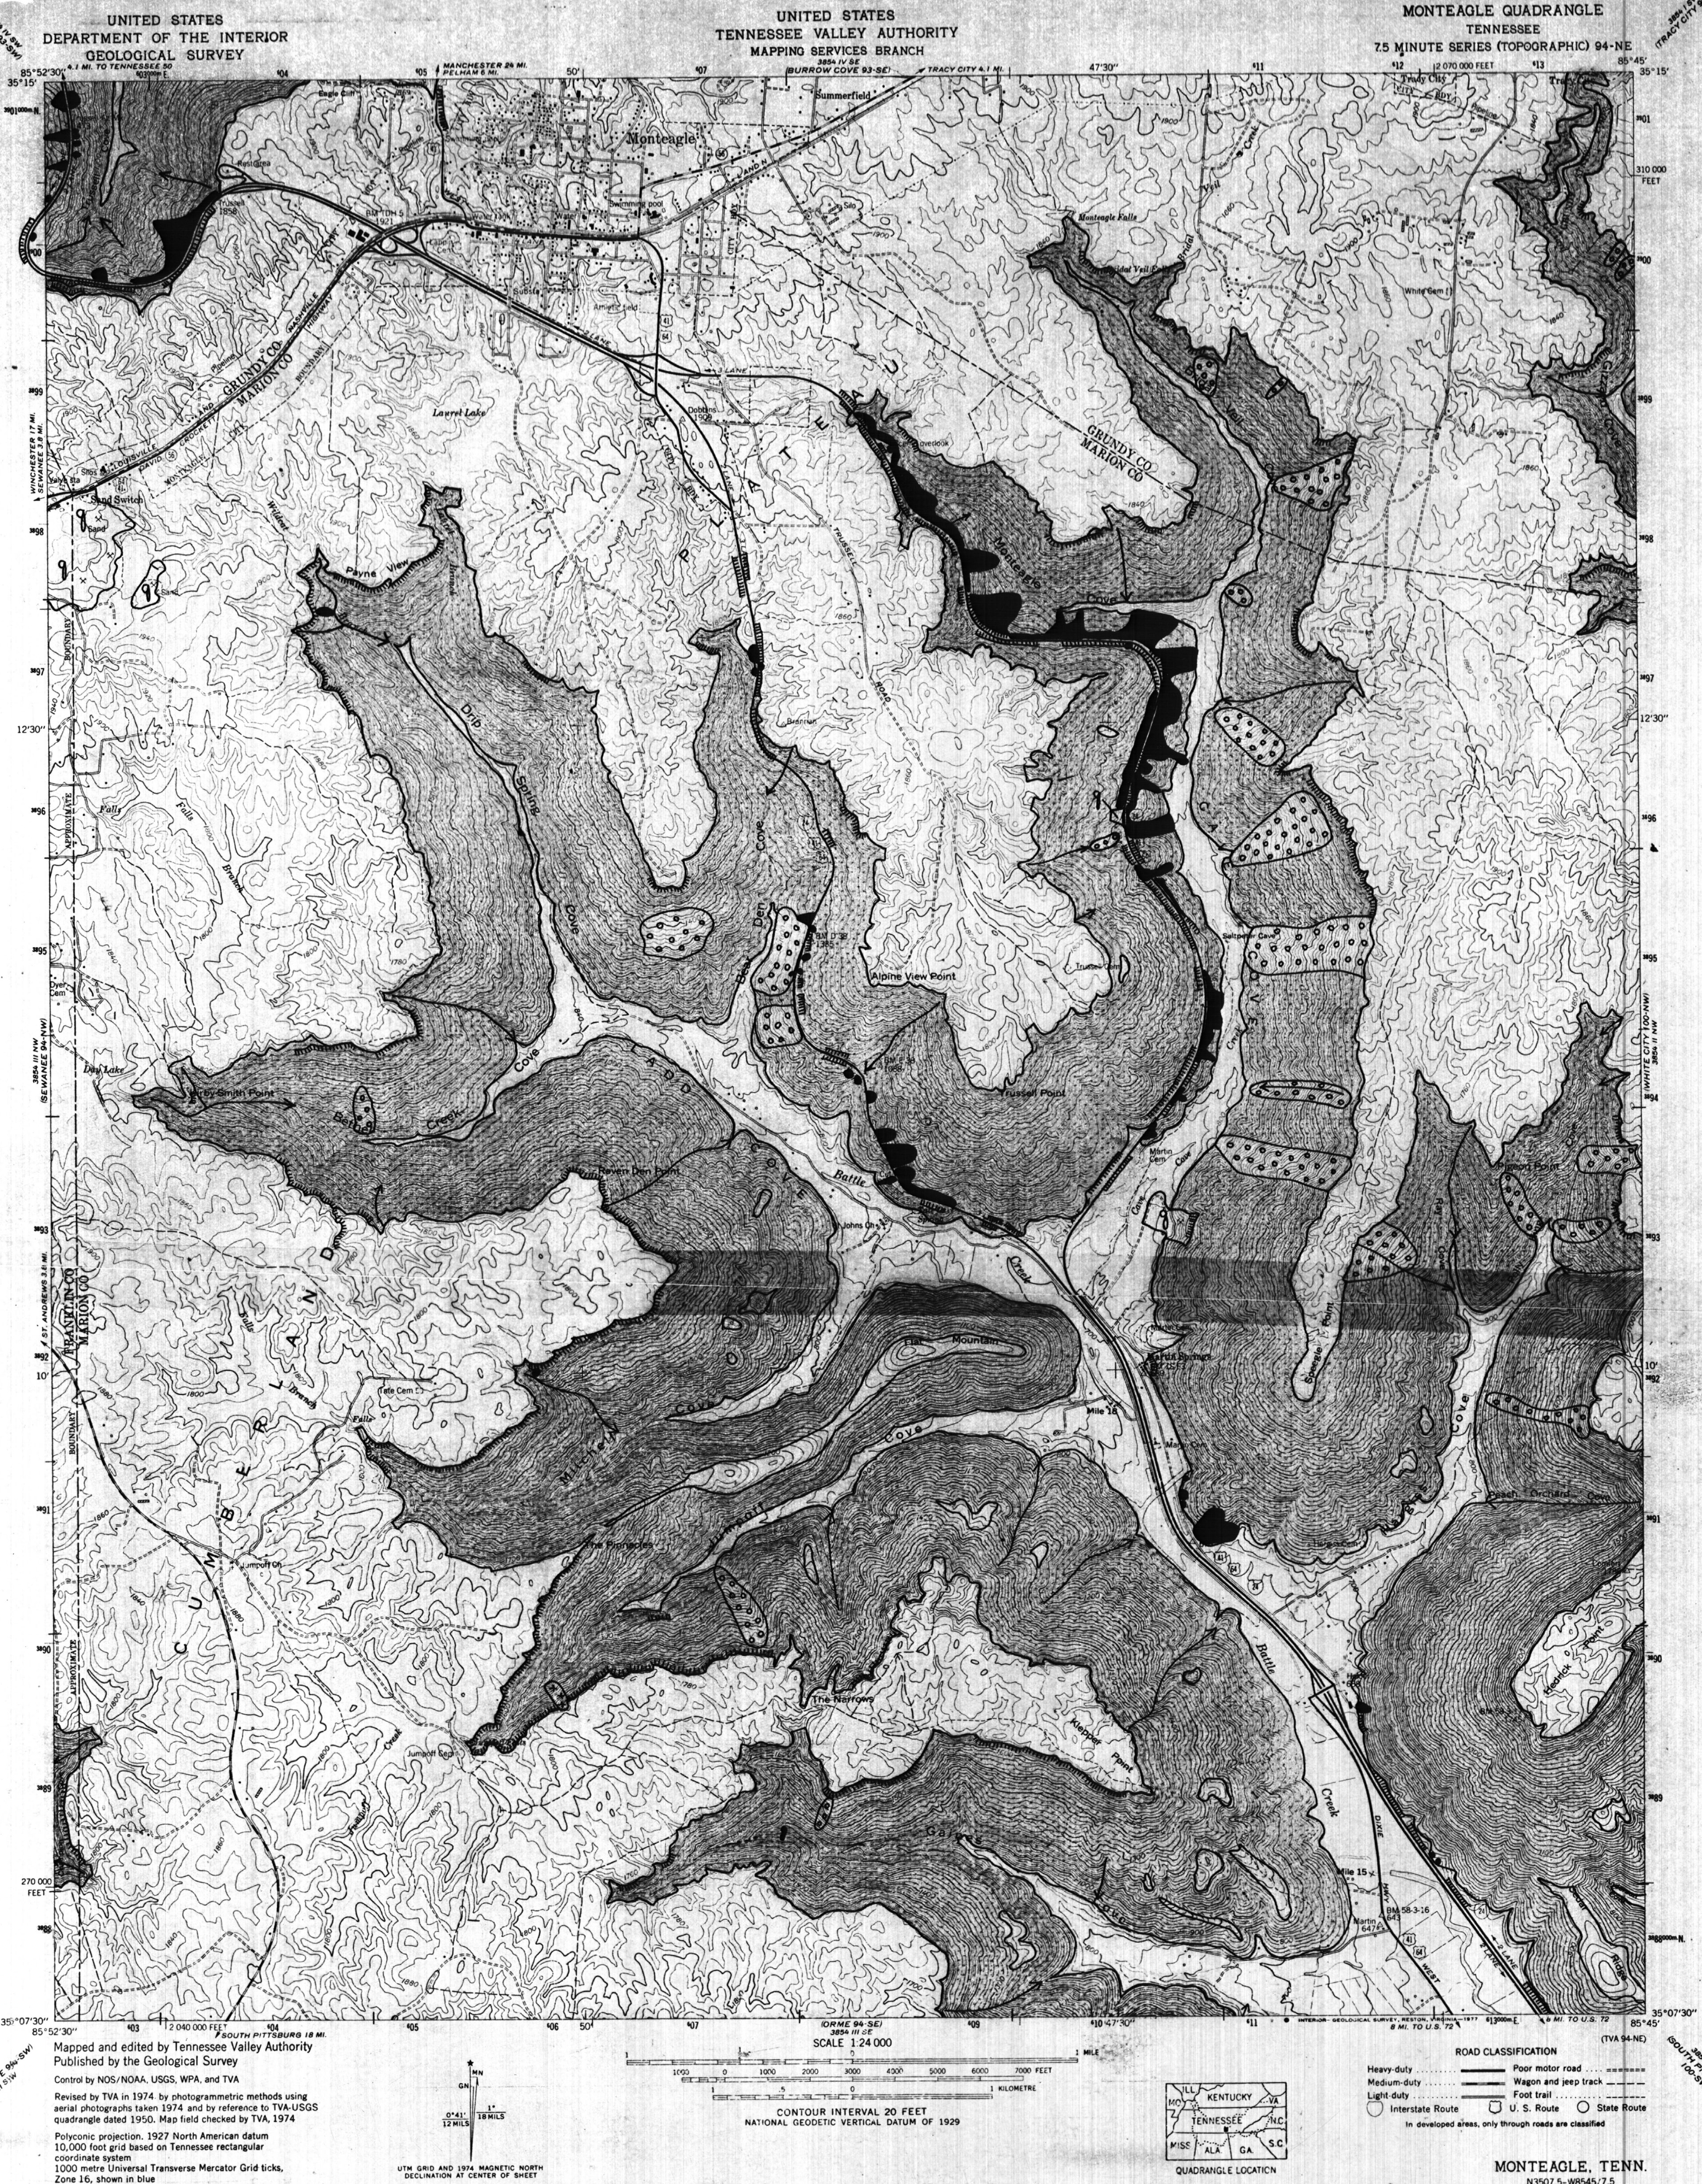
Landslides and related features interpreted from aerial photographs:
1:75,000 (Black and White) 1974
1:20,000 (Black and White) 1973

Photointerpretation and field check 1981
This report is preliminary and has not been reviewed for conformity with U.S. Geological Survey editorial standards.

- ACTIVE OR RECENTLY ACTIVE LANDSLIDE**
Complex landslide composed of earthflow, debris slide, earth and rock slump. Identified from historical records, and from scars, debris and other field evidence. Ground extremely unstable; sliding accelerated by excavation, loading and changes in drainage conditions. May include areas with several active slides too small to be shown separately. Questioned where doubtful.

- OLD LANDSLIDE**
Area of extensive hummocky ground caused by earthflow and earth and rock slump. Lacks clear evidence of active sliding. Relatively stable in natural, undisturbed state, generally not affected by small structures properly sited in areas away from the edge of the toe; can be reactivated by extensive, rapid excavation, loading, and changes in ground water and surface water conditions. Area of old landslide probably includes recent ones not identified from field evidence or otherwise documented. Upslope boundary of landslide generally defined by modified scarp, but downslope (toe) may be gradational and not well defined. Questioned where doubtful.

- COMBINATION LANDSLIDE**
Area of recent and old slides in which individual slides are not identified.
- COLLUVIAL SLOPE**
Valley wall along major streams with slope as steep as 40 (85%); stony, clayey silt soil up to 50 ft. (15 m) thick; commonly buttressed by a terrace or bench at the toe of the slope; very susceptible to sliding by cutting of toe area, removal of terrace or bench, and overloading; slide commonly activated without apparent cause.

- COLLUVIAL SLOPES WITH LANDSLIDES**
Landslides too small or obscure to map individually.
- AREAS SUSCEPTIBLE TO DEBRIS FLOWS AND DEBRIS AVALANCHES**
Primarily shallow, narrow ravines and chutes with accumulation of stony colluvium generally 10 ft. (3 m) or less in thickness; susceptible to rapid movement during intense rainfall. Most ravines and chutes designated show evidence of former debris flows and avalanches.

- AREAS SUSCEPTIBLE TO ROCKFALL**
Steep, locally vertical, natural and man-made slopes and cliffs, 15 ft. (4.5 m) or more high; formed dominantly of sandstone, limestone, sandy shale, mudstone and claystone. Interbedded mudstone, claystone and shale weather rapidly leaving sandstone and limestone rock faces unsupported.

- SOIL AND ROCK SUSCEPTIBLE TO LANDSLIDING**
Soil and rock similar to that involved in landslides elsewhere in map area; primarily areas underlain by claystone, mudstone and shale associated with other rock types. Rock weathers rapidly on exposure forming clayey soil highly susceptible to sliding. Includes coves (U-shaped, shallow valleys) containing thick layers of clayey soil that are very susceptible to sliding where excavation breaks continuity of slope and where overloaded by artificial fill.

- AREAS LEAST PRONE TO LANDSLIDES**
Map areas in which no patterns or symbols are shown; primarily valley floors, ridge tops and broad benches; modification by excavation and fill may lead to local landslides.
